Inspection Report

FRONT VIEW

Canadian Home Inspection

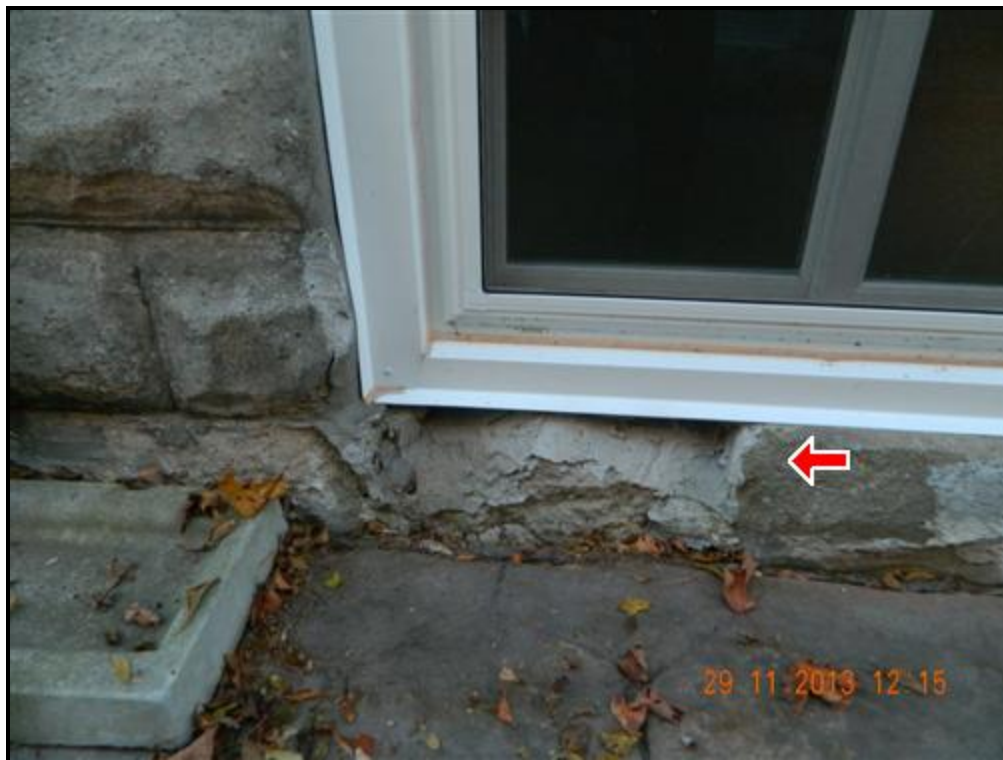
1.0 Picture 1 NORTH SIDE

1.0 Unable to determine the extent of water intrusion or how often it will occur. \$200 REPAIR

Unable to determine the extent of water intrusion or how often it will occur. \$200 REPAIR

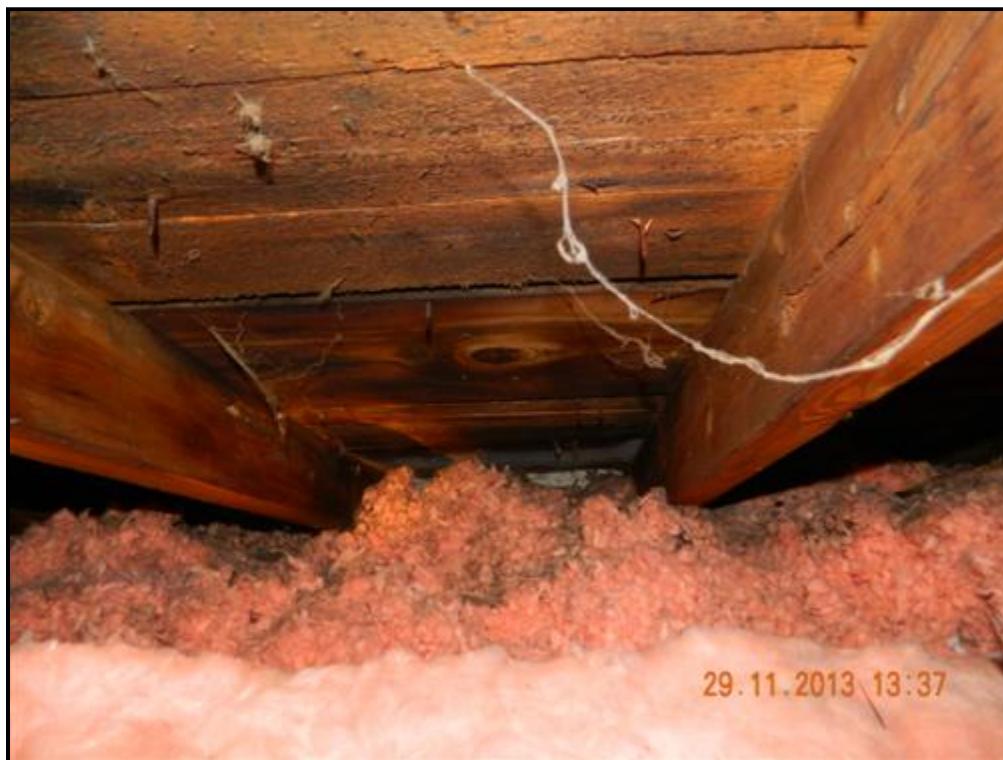
1.5 Picture 1 ATTIC VIEW

1.5 ATTIC VIEW SHOWING FROST AT EAVES.

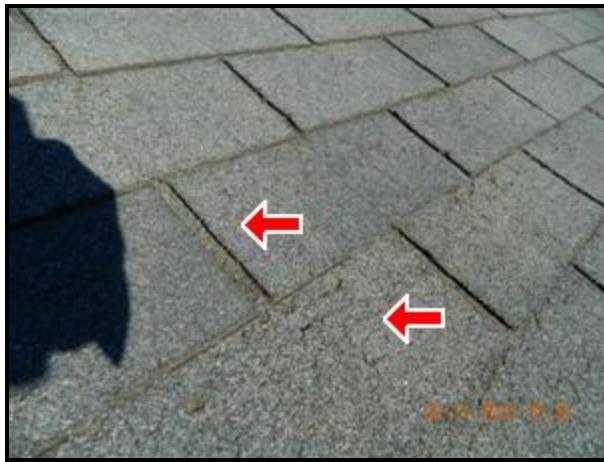
3.0 Picture 1 ROOF SHINGLE VIEW

3.0 (1) Three or more layers of roof covering exist. Next roof, I recommend a complete tear-off and install new. THIS IS A \$5000 JOB

(1) Three or more layers of roof covering exist. Next roof, I recommend a complete tear-off and install new. THIS IS A \$5000 JOB

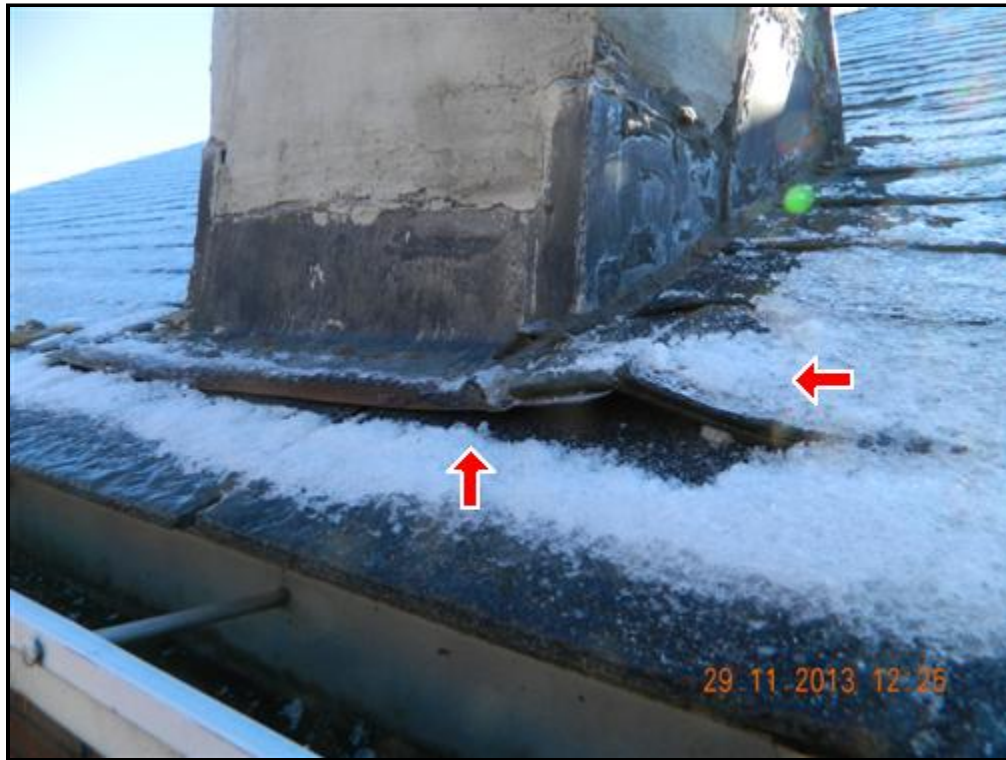
3.0 Picture 2

(2) Shingles around chimney area on (North side of home) shows signs of a repair attempt due to visible caulking. It appears that leak has been corrected. Roof covering will need replacing before 5 years. Recommend repair or replace as needed using a qualified person. THIS A \$5000 DOLLAR REPAIR

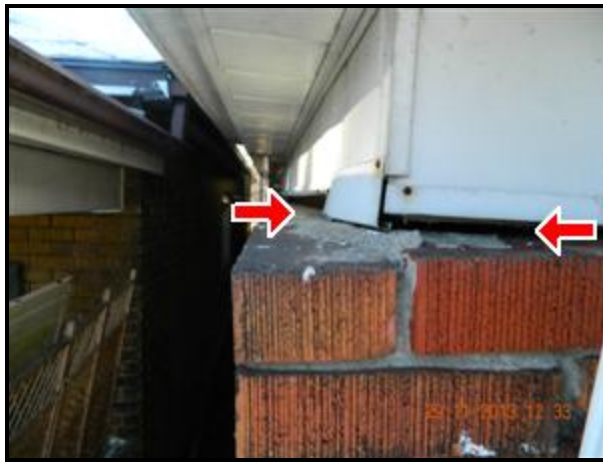
3.1 Picture 1 FRONT PILAR VIEW

3.1 NEED INSPECTION FOR FURTHER DAMAGE CONTROL.

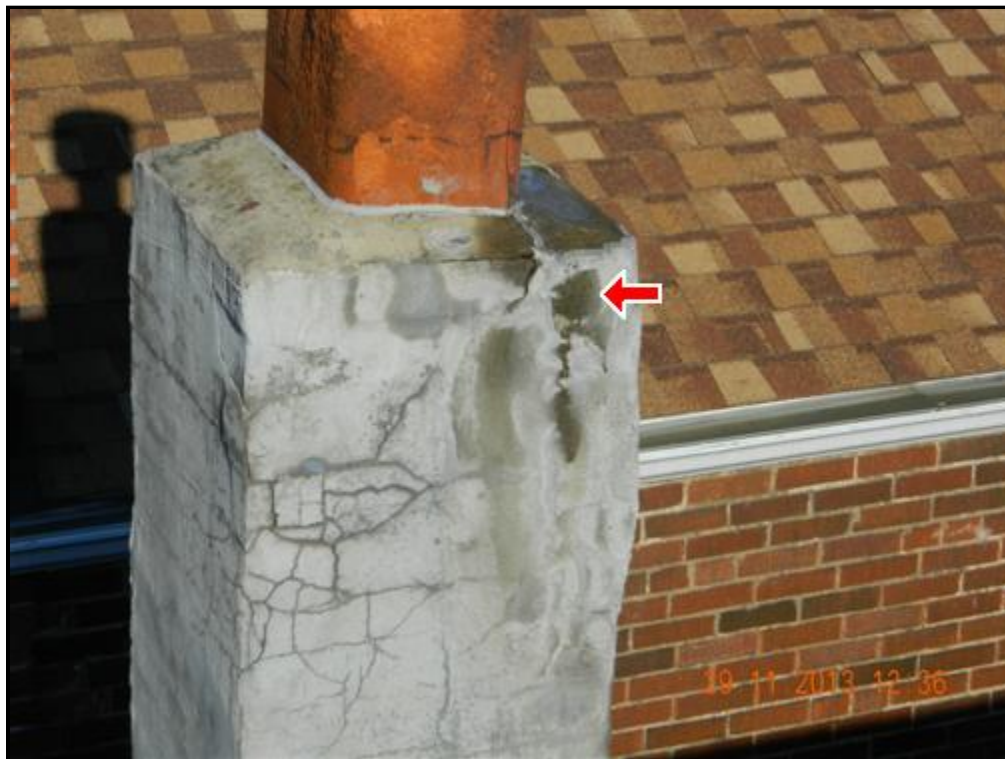
3.2 Picture 1 CHIMMEY VIEW

3.2 (1) Masonry chimney deteriorated Repairs are needed. Recommend a qualified contractor inspect and repair as needed. THIS A \$2000-3000 REPAIR FOR NEW CHIMMEY.

6.3 Chimney mortar and bricks are deteriorated from roof line and is in need of replacment. Recommend a certified chimney sweep inspect further.\$2000-\$3000 repair.

(1) Masonry chimney deteriorated Repairs are needed. Recommend a qualified contractor inspect and repair as needed. THIS A \$2000-3000 REPAIR FOR NEW CHIMMEY.

Chimney mortar and bricks are deteriorated from roof line and is in need of replacment. Recommend a certified chimney sweep inspect further. \$2000-\$3000 repair.

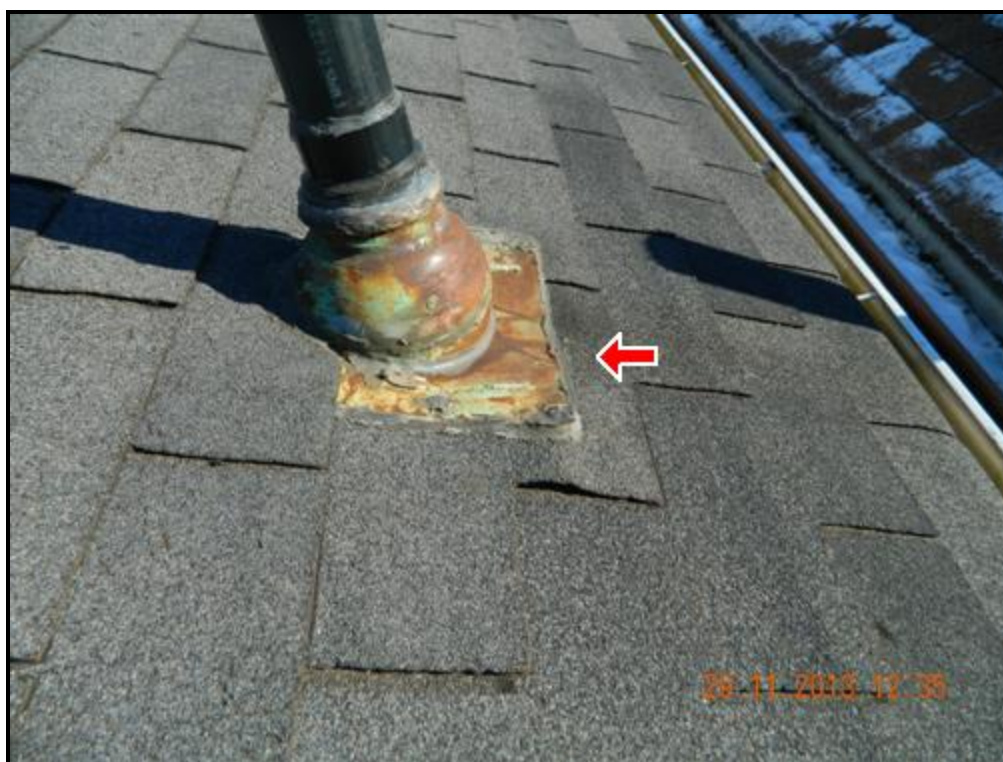
3.2 Picture 2 PLUMING VENT VIEW

(2) Plumbing vent pipe (through roof) needs flashing boot replaced (3 inch diameter) on left side (facing front). This area can leak if not corrected. Recommend a qualified roof contractor inspect further and correct as needed.

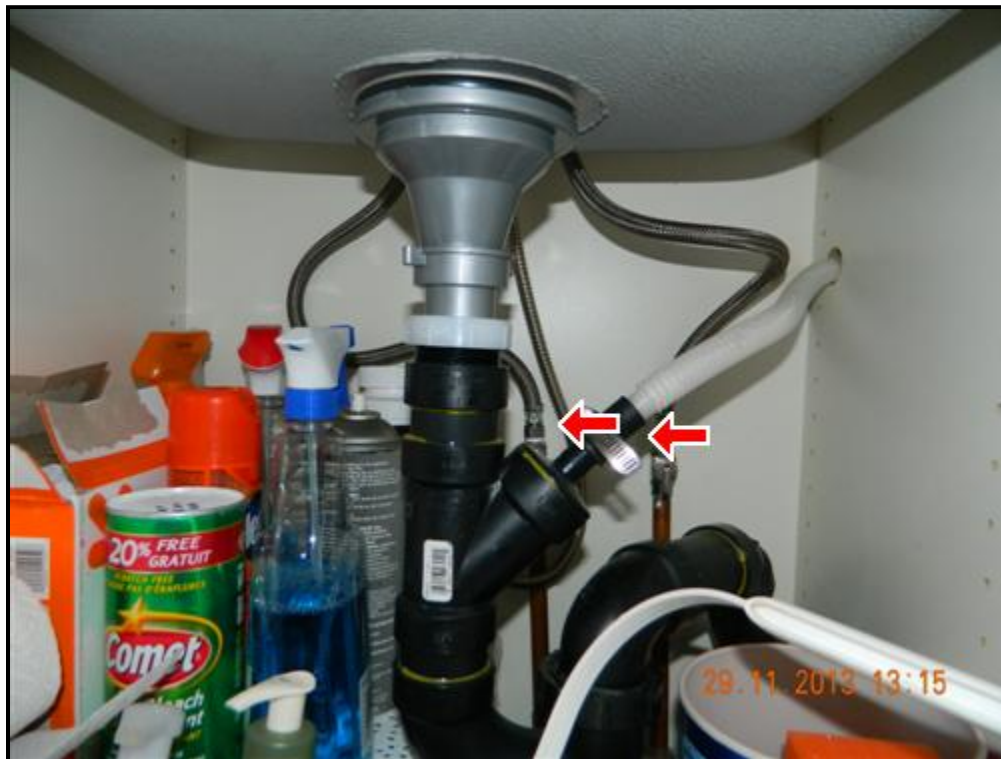
4.3 Picture 1 KICTHEN VIEW

4.3 PROPER PLUMING FOR KITCHEN SINK.

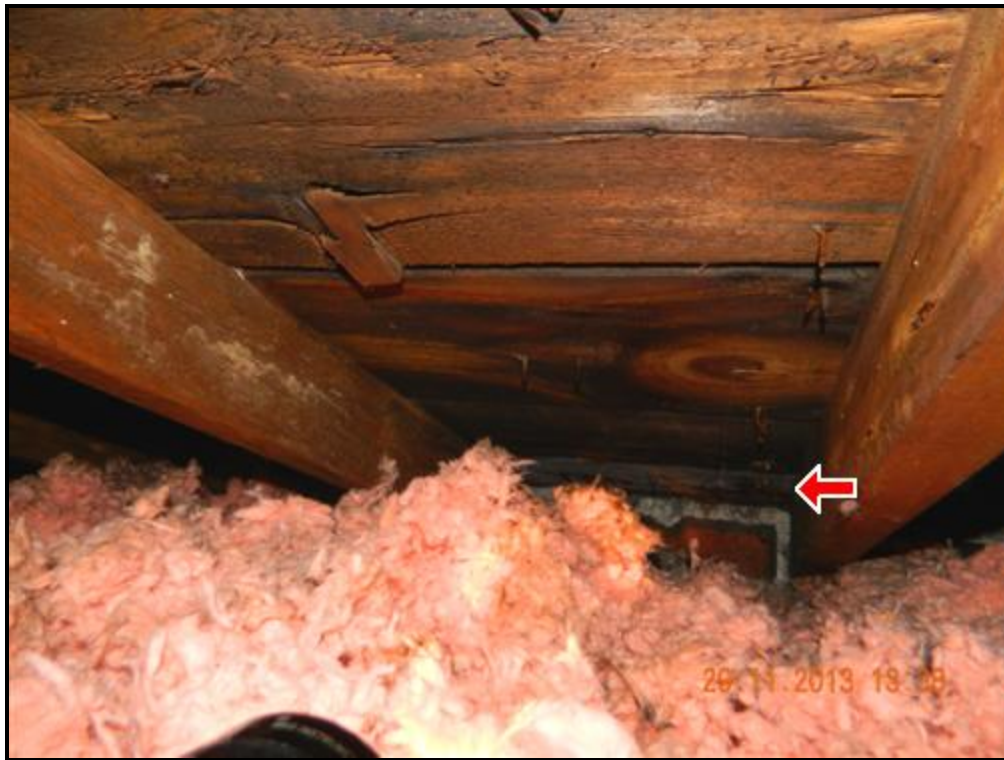
9.1 Picture 1 FROST VIEW

9.1 (1) Ventilation was not added, when most recent roof covering was installed. Recommend increasing the ventilation to promote life expectancy of covering.

(2) Roof covering has recently been replaced and more ventilation should be added to promote life expectancy. Mold could develop if situation not corrected. Attic shows signs of frost in soffit areas.

(1) Ventilation was not added, when most recent roof covering was installed. Recommend increasing the ventilation to promote life expectancy of covering.

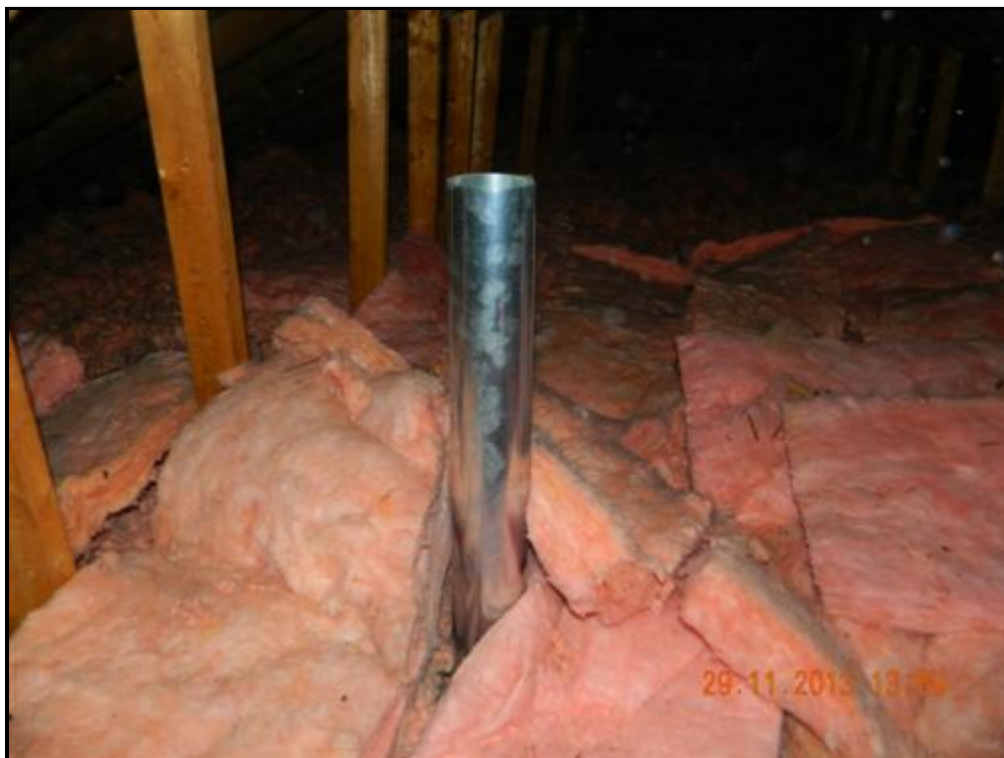
9.2 Picture 1 ATTIC VIEW

9.2 Kitchen exhaust venting into attic WRONG! COULD CAUSE MOULD PROBLEMS IF NOT CORRECTED. USE PROPER ATTIC PERSON FOR REPAIR. \$300 REPAIR ESTIMATE.

Kitchen exhaust venting into attic WRONG! COULD CAUSE MOULD PROBLEMS IF NOT CORRECTED. USE PROPER ATTIC PERSON FOR REPAIR. \$300 REPAIR ESTIMATE.
